Blade is Cupping / Rounding Off Leading Edge of Board or Not Completing Vertical Cut Through Board

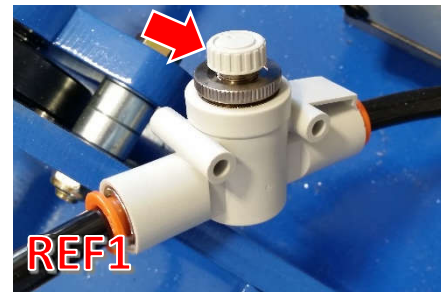
Possible Problem 2: Flow control (white and orange tee like fitting) may be too restrictive. Confirm it is open enough to allow movement, but limit slamming (REF1).

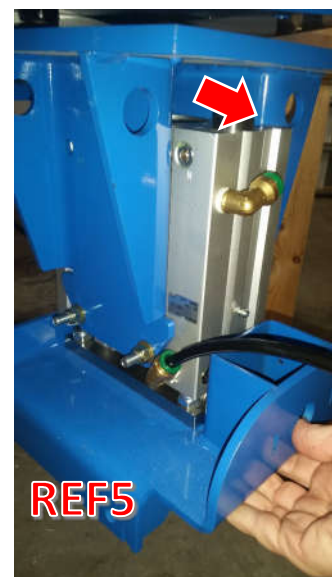
Possible Problem 4: Carriage air cylinder seals are failing.

With cylinder in up position, remove top air hose, listen for air leaking at the cylinder port (REF5) if a leak is heard here, the cylinder needs rebuild or replaced. Rebuilding cylinder requires 1 SMC rebuild kit. Check part number on cylinder.

Cylinders ending in A get kit #PC-0012-1

Cylinders ending in Z get kit #PC-0012-2

Replacement cylinder for single carriage style: PC-0012M

Replacement cylinder for double carriage style: PC-0012L

If no leak is heard at cylinder, listen at hose for ceram valve leak. If ceram is leaking, it needs to be cleaned or replaced. No rebuild kit available.
